Manhole Inspection Summary

Manhole # S37EE_010MH

Insp Date: **7/6/09 10:30 AM**

Location Address: **1132 HOMEWOOD AVE**

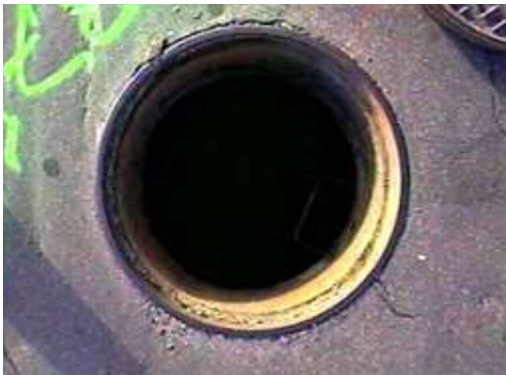
Defect 3

Offset: **2** (in.)

FRAME OFFSET

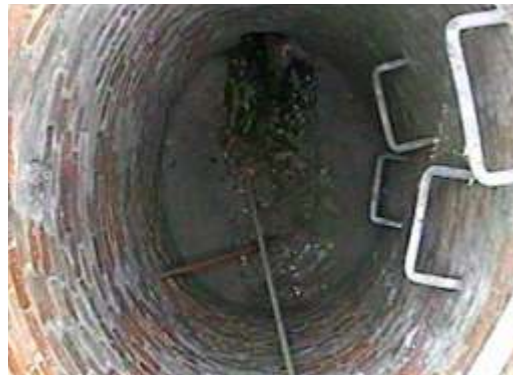
Defect 1

Count: **5** Missing: **0** ☒ **Corroded**

CORRODED STEPS

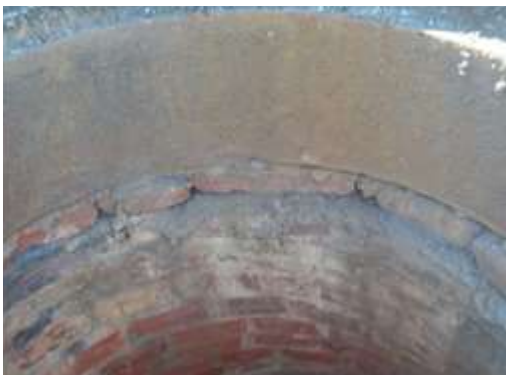
Defect 2

Condition: ☐ Sound ☐ Cracked ☐ Root Intrusion ☒ **Loose Brick** ☐ Deteriorated

LOOSE BRICKS ON CHIMNEY

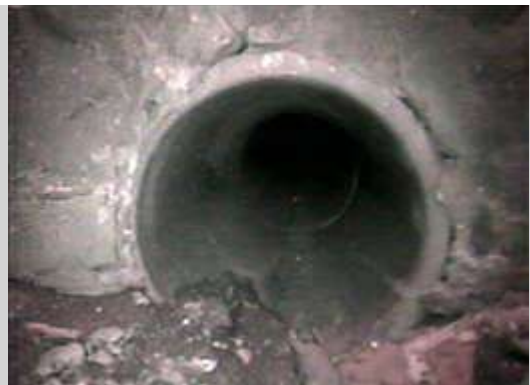
12 O'Clock Outflow

8 in. Circular Gravity Sewer
Pipe Out @ 12 O'Clock
